North Shore Hospital - Auckland New Zealand

Ward 14 – part only – Work was completed Nov 2018

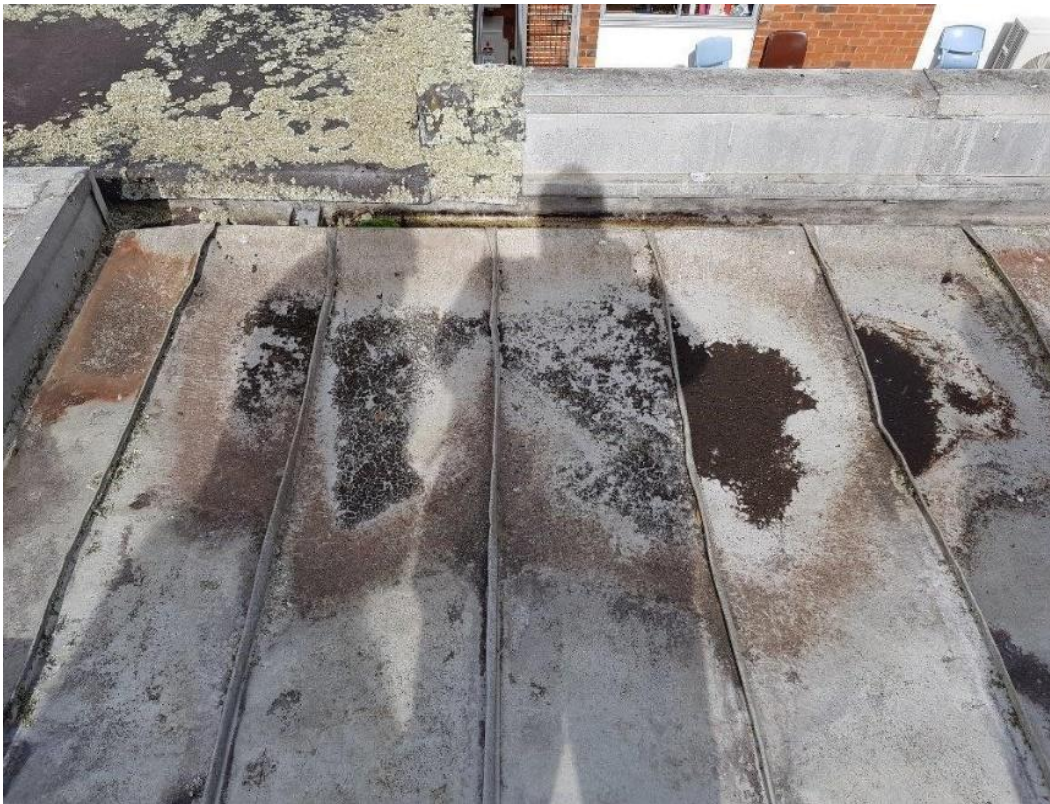
The roof was in need of some major repair work with fixing down the existing Aluminium Alstrip where it had lifted and also there were a number of metal flashings that we replaced. There were several other fixing issues and splits in the aluminium were also present.

The roof needed urgent attention, it was leaking into some of the ward rooms below and they could not be occupied. This was the typical condition of the roof area. We had it high pressure washed prior to replacing any flashings.

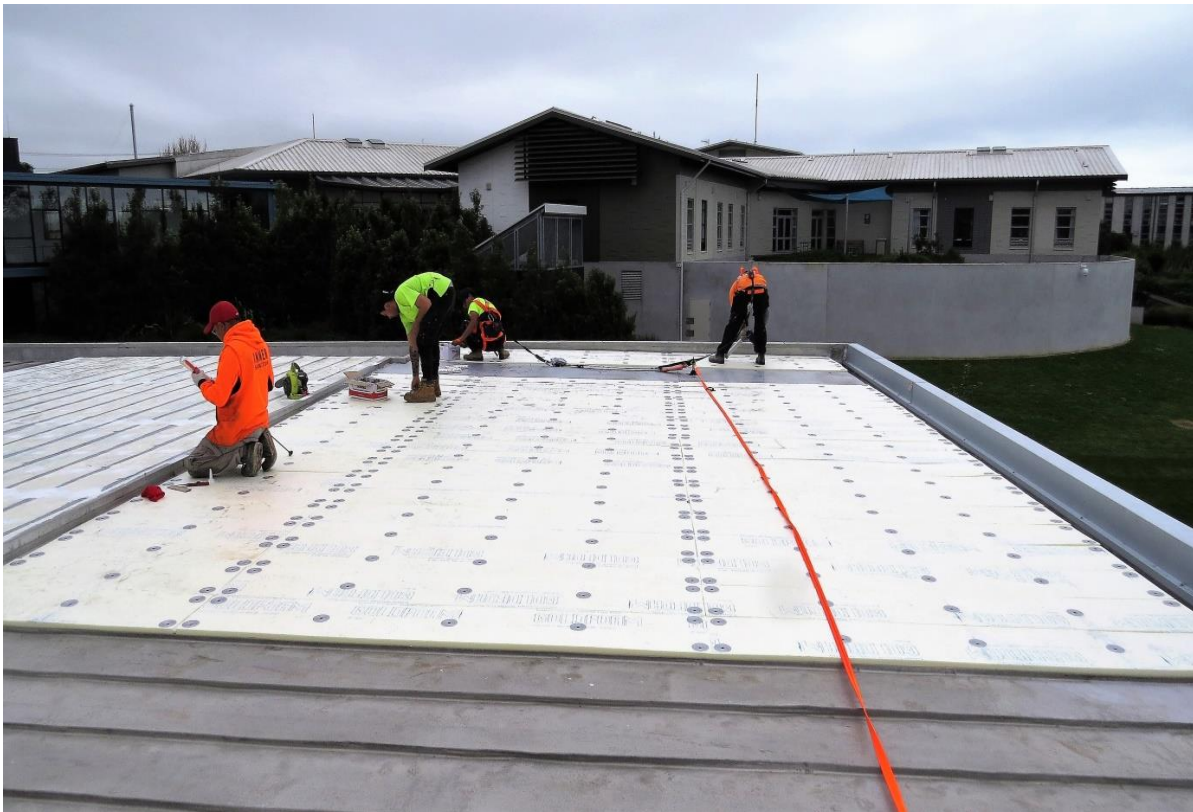
The system devised was infilling the Alstrip with 355mm x2400mm x 50mm High Density Foam in-between the ribs. This was first glued then fixed mechanically with washers and screws. Due to the HDF being 50mm high we needed to provide a flush surface for the OneCoat to be sprayed to, the The system devised was infilling the Alstrip with 355mm x2400mm x 50mm High Density Foam in-between the ribs.

This was first glued then fixed mechanically with washers and screws. Due to the HDF being 50mm high we needed to provide a flush surface for the OneCoat to be sprayed to, the ribs were only 30mm high, so we infilled the top of the ribs with backing rod and then applied an MS Firestop Sealant to provide a flush surface.

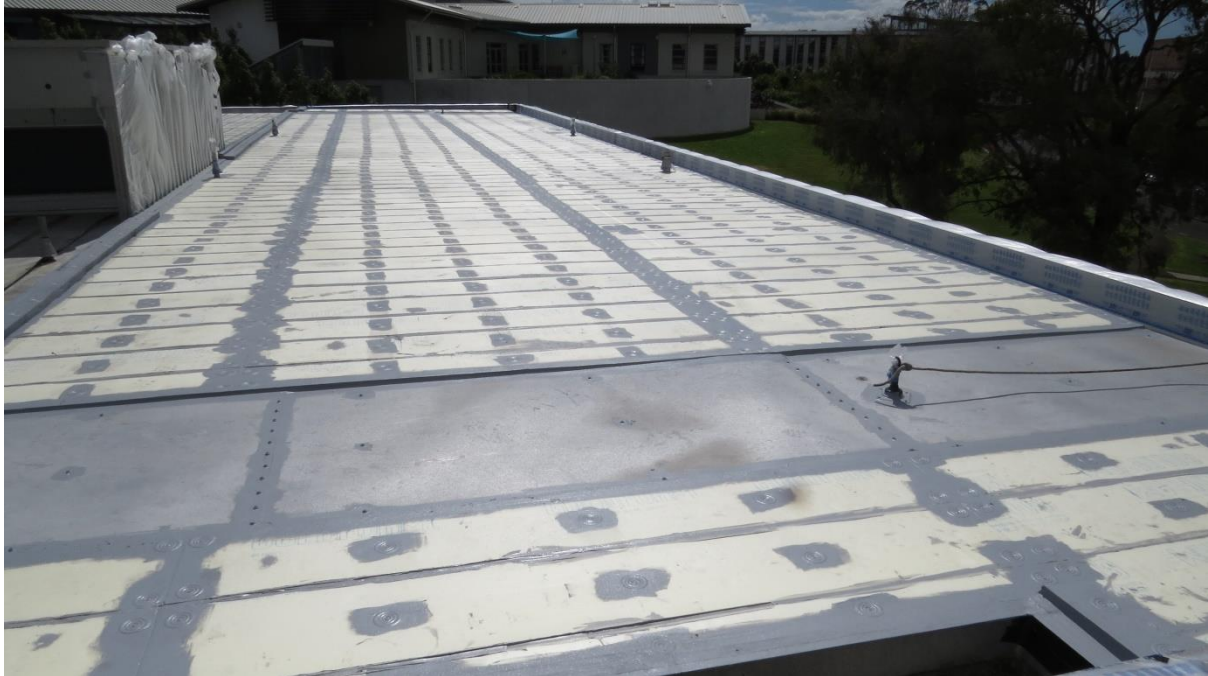
Once glued and mechanically fixed we used our NP7 Elastomagic Cement to seal all mechanical fixings making them watertight and also providing a bond breaker to the washers and HDF. Prior to the OneCoat application all cross joins of HDF were detailed with NP7 as a bond breaker to take up any movement that may occur.

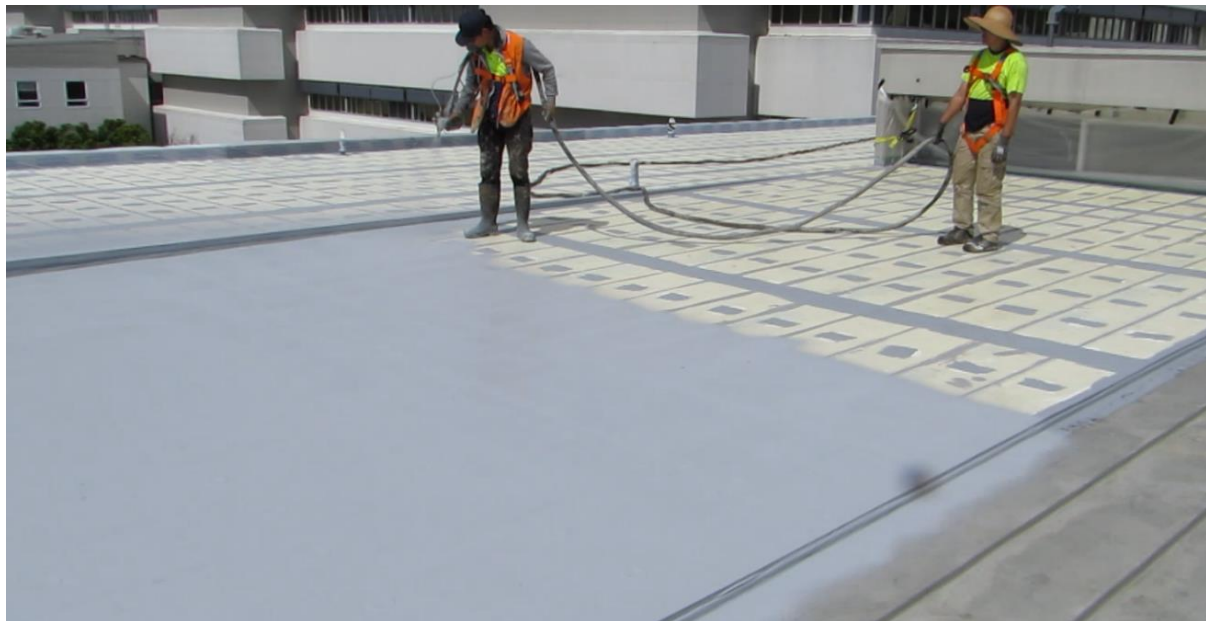
On finishing all detail works, we masked all appropriate areas to prevent any overspray. Priming was first completed then the application of Neptune Pacific, NP OneCoat was completed.

OneCoat spraying application. Not only have we achieved a watertight roof but this client will now enjoy the benefits of a warm roof and reflectivity of 80% of UV.

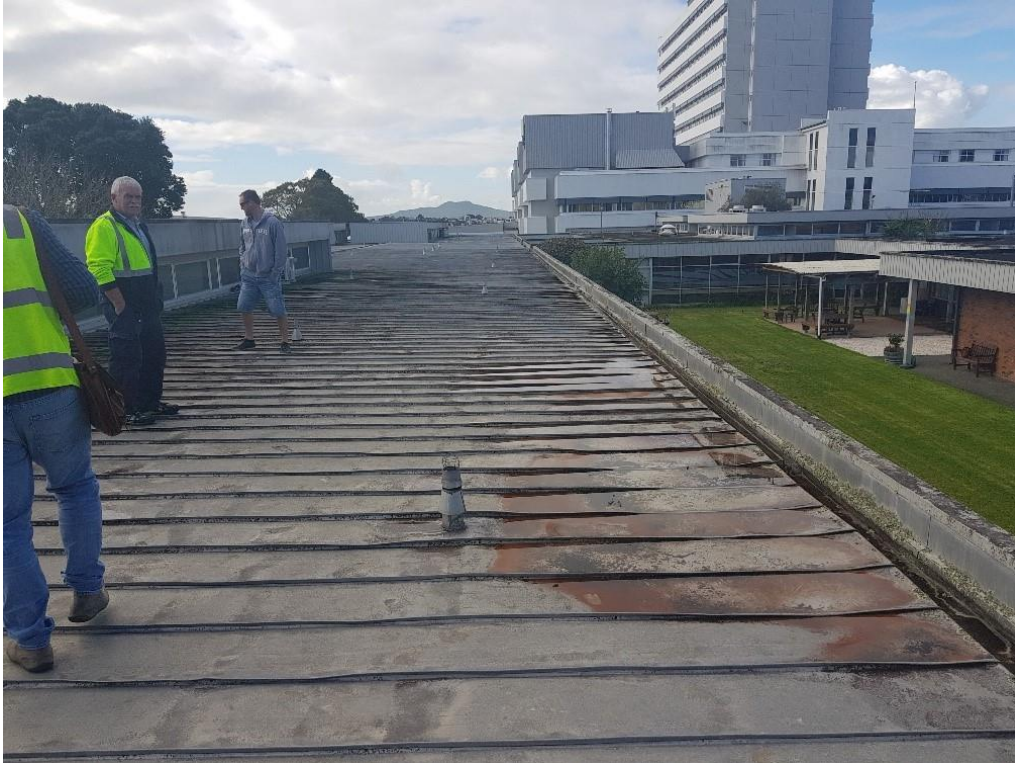
Before - Neptune Pacific Ltd OneCoat Application

What a remarkable difference, this roof is now watertight and looking good.

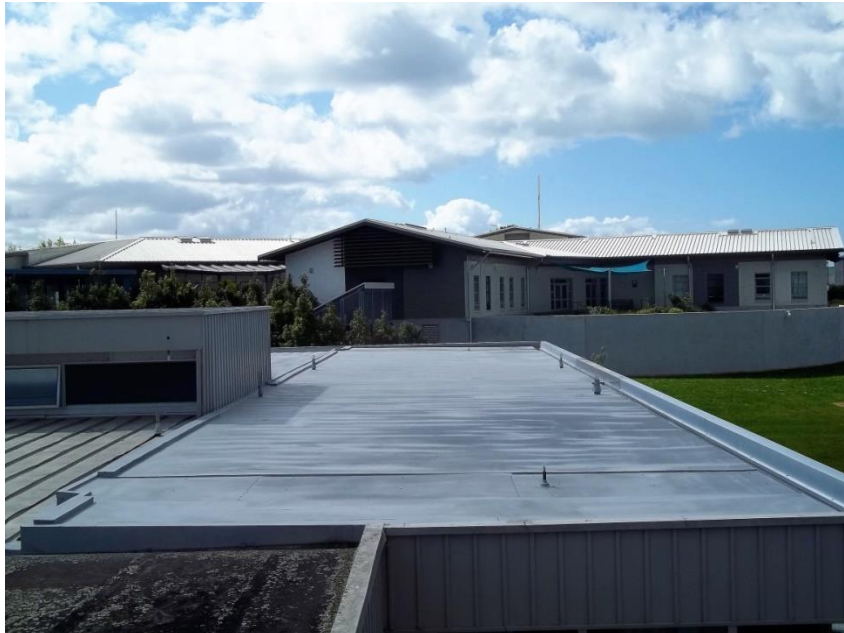
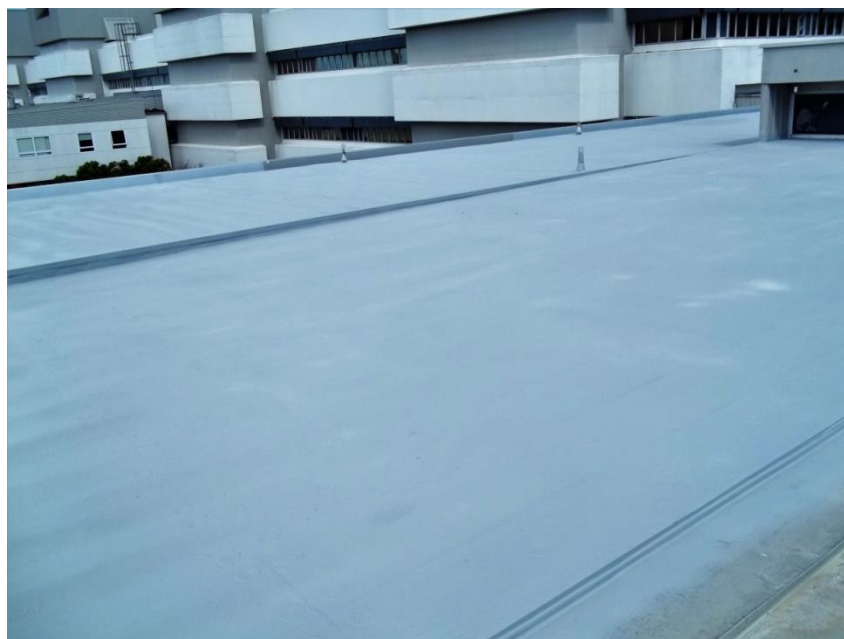
This hospital now has a cost effective roof renewal that is watertight. They have gained the benefits of insulation to reduce electricity costs and they have 80% reflectivity of UV rays. We have issued a comprehensive warranty for application and product. They have received all of these benefits with no disruption to daily business and no inconvenience to staff or patients.
