Hospital on the North Shore- Auckland New Zealand

Work was completed Nov 2018

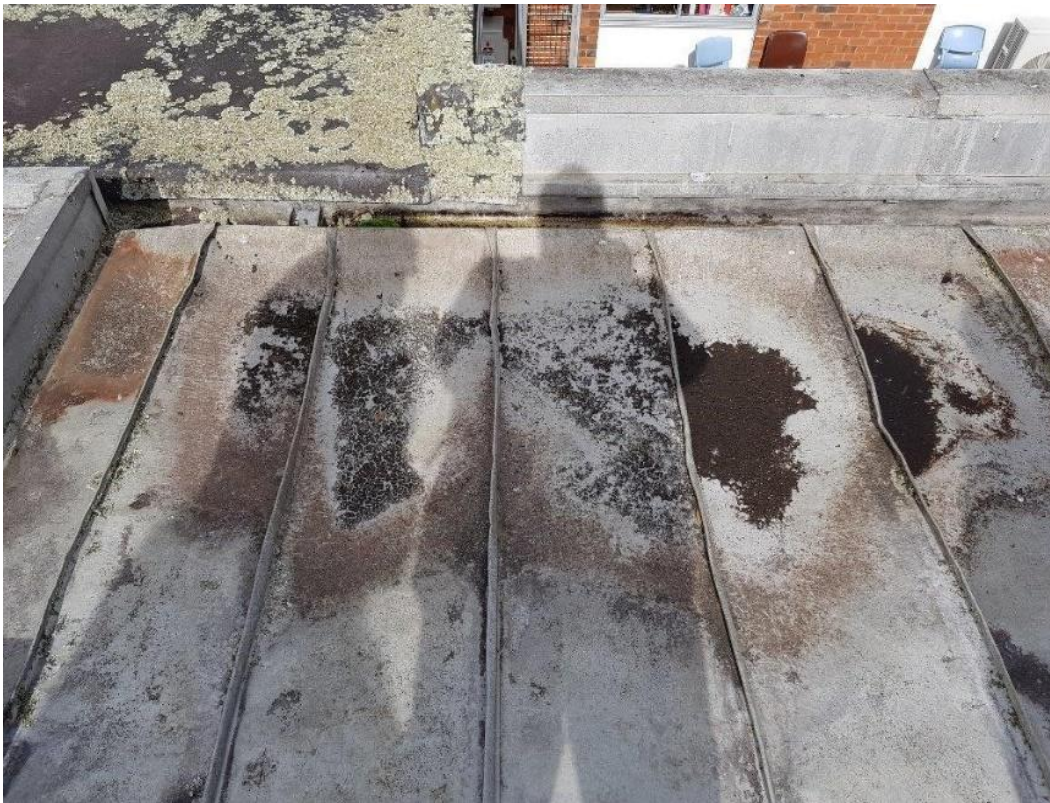
The roof was in need of some major repair work with fixing down the existing Aluminium Alstrip where it had lifted and also there were a number of metal flashings that we replaced. There were several other fixing issues and splits in the aluminium were also present.

The roof needed urgent attention, it was leaking into some of the ward rooms below and they could not be occupied. This was the typical condition of the roof area. We had it high pressure washed prior to replacing any flashings.

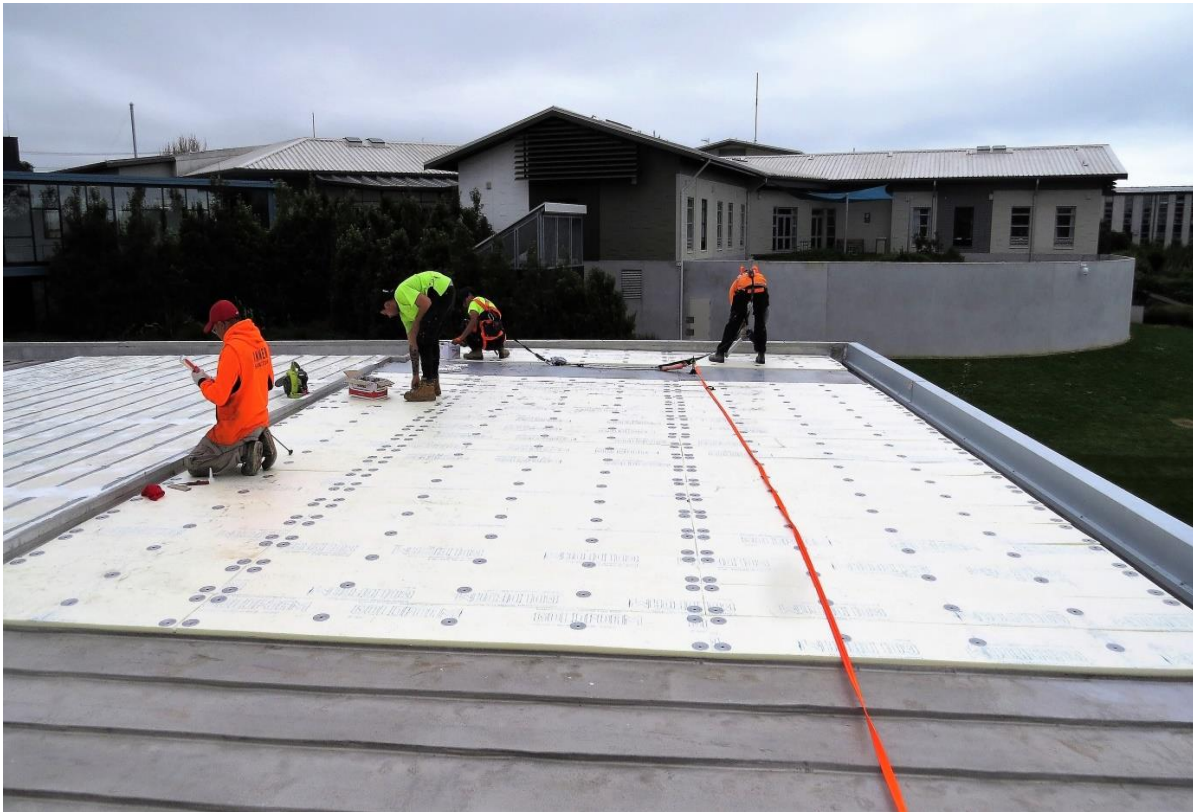
The system devised was infilling the Alstrip with 355mm x2400mm x 50mm High Density Foam in-between the ribs. This was first glued then fixed mechanically with washers and screws. Due to the HDF being 50mm high we needed to provide a flush surface for the OneCoat to be sprayed to, the The system devised was infilling the Alstrip with 355mm x2400mm x 50mm High Density Foam in-between the ribs.

This was first glued then fixed mechanically with washers and screws. Due to the HDF being 50mm high we needed to provide a flush surface for the OneCoat to be sprayed to, the ribs were only 30mm high, so we infilled the top of the ribs with backing rod and then applied an MS Firestop Sealant to provide a flush surface.

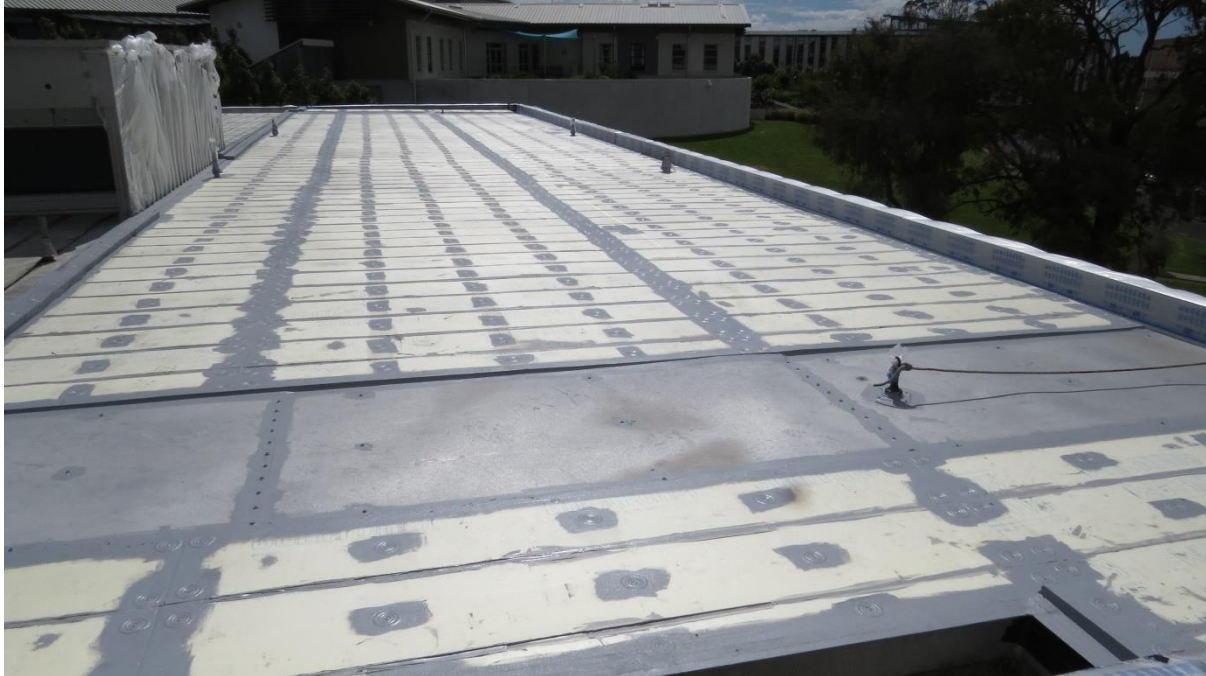
Once glued and mechanically fixed we used our NP7 Elastomagic Cement to seal all mechanical fixings making them watertight and also providing a bond breaker to the washers and HDF. Prior to the OneCoat application all cross joins of HDF were detailed with NP7 as a bond breaker to take up any movement that may occur.

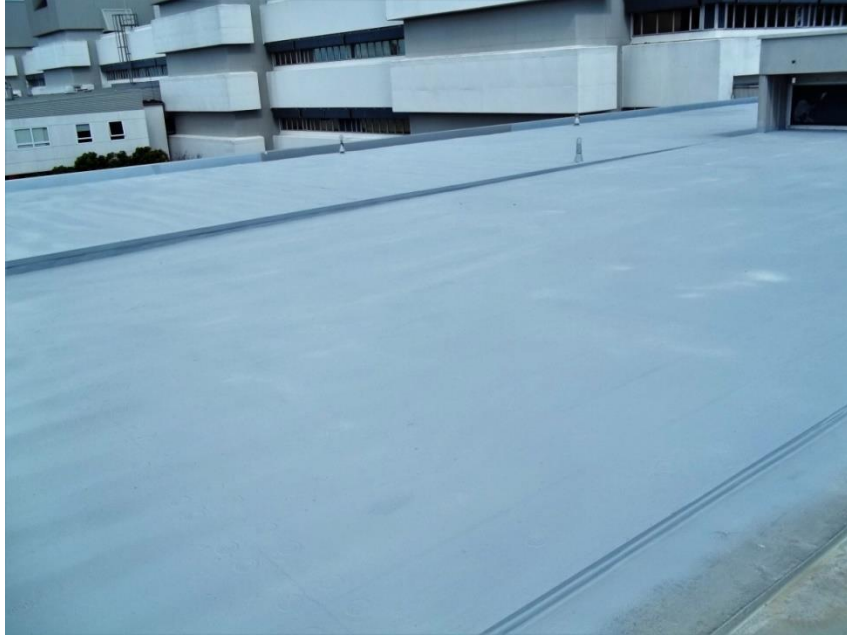
What a remarkable difference, this roof is now watertight and looking good.
