Unit B2, 39 Arrenway Drive
Albany, Auckland
New Zealand

Case Study: Application of Neptune Pacific Ltd OneCoat - NP OneCoat work was completed in May 2018.

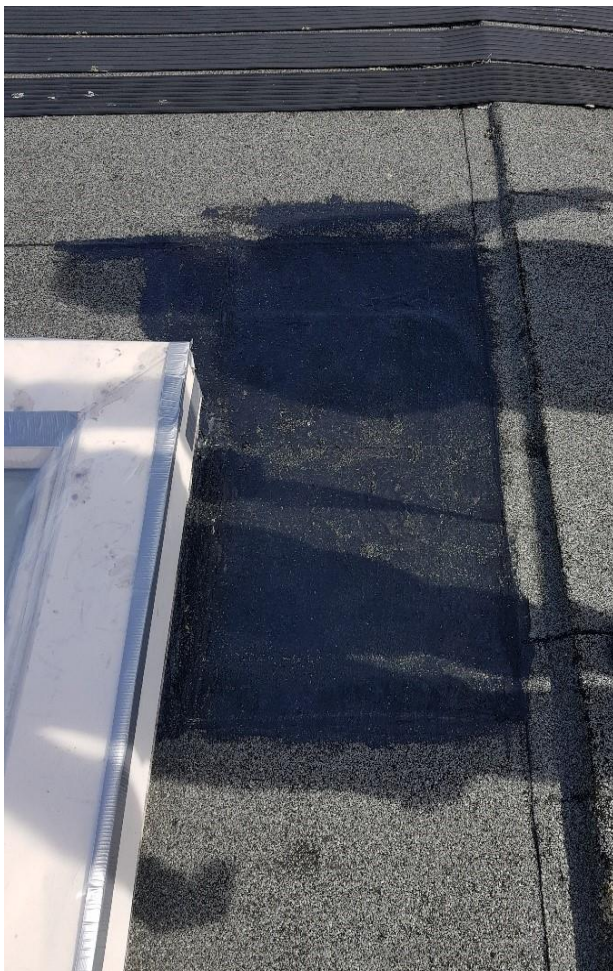
This home is overlooking the beautiful Waitemata Harbour. There were 5 small roofs totalling approximately 200m². The roofs had an existing single layer mineral chip Torch On membrane that was approximately 18 years old. The roofs were showing signs of wear and need to be replaced, repaired or renewed. The owner was on board with us every step of the way confident in the system that we provided.

These are small sections of a couple of the roofs before the application of NP OneCoat

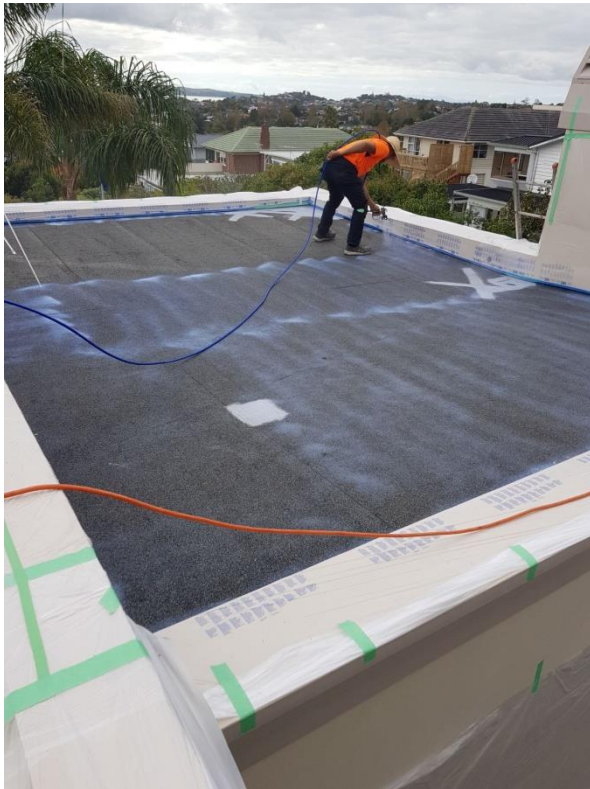
***The masking is complete,
the priming begins.***

We gave the roof a high pressure wash and then proceeded to do all detail work and masking for the finish coat of Neptune Pacific Ltd OneCoat Grey, this was to be a finished dry film thickness of 1.5mm.

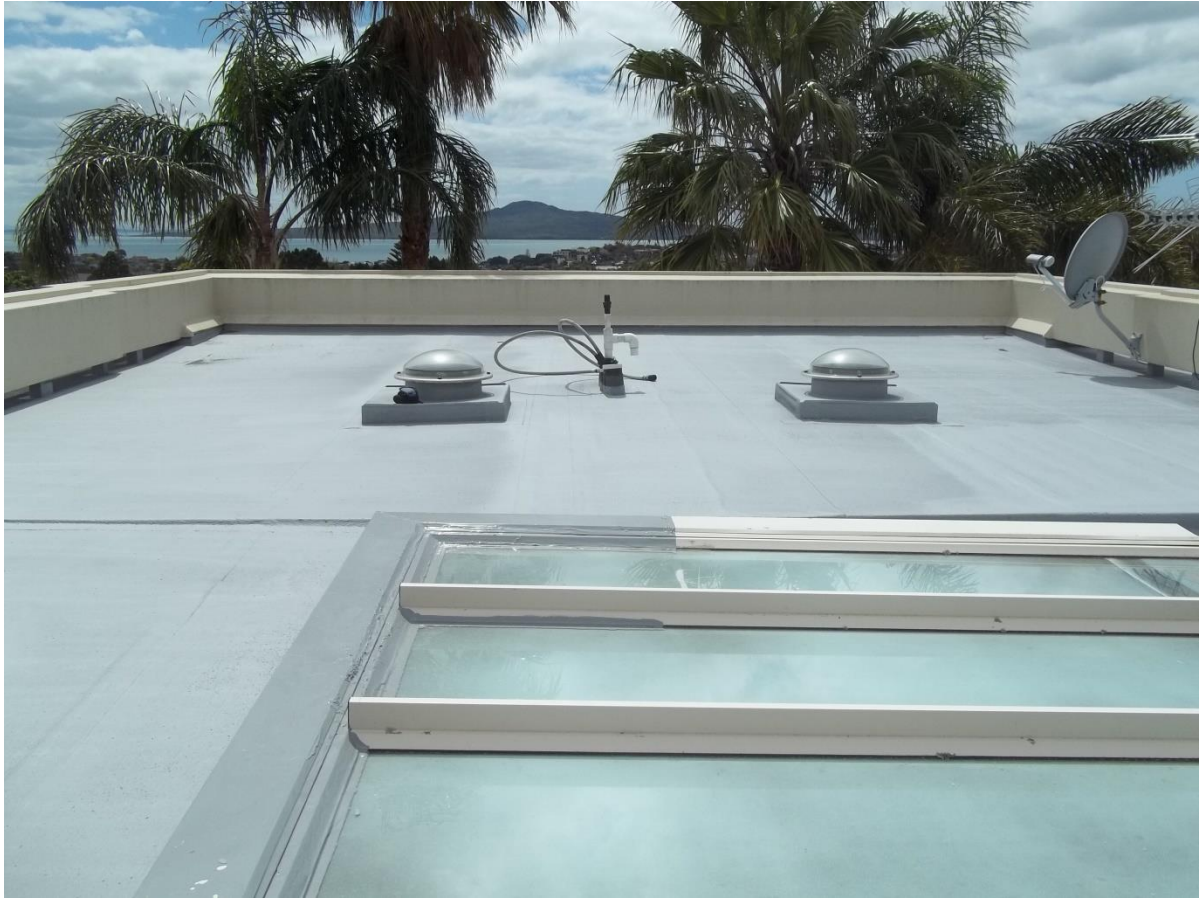
After the application of NP OneCoat

Great result with very happy home owners.

With the dry finish of 1.5m we were able to provide the property owner with a 15 year material warranty, and because this system is renewable it is able to be recoated.
